## Case studies and analysis of mine shafts incidents in Europe

Amélie Lecomte, Romuald Salmon, W. Yang, Alec Marshall, M. Purvis, S. Prusek, Slawomir Bock, L. Gajda, J. Dziura, Agustin Munos Niharra

## **Case studies and analysis of mine shafts incidents in Europe**

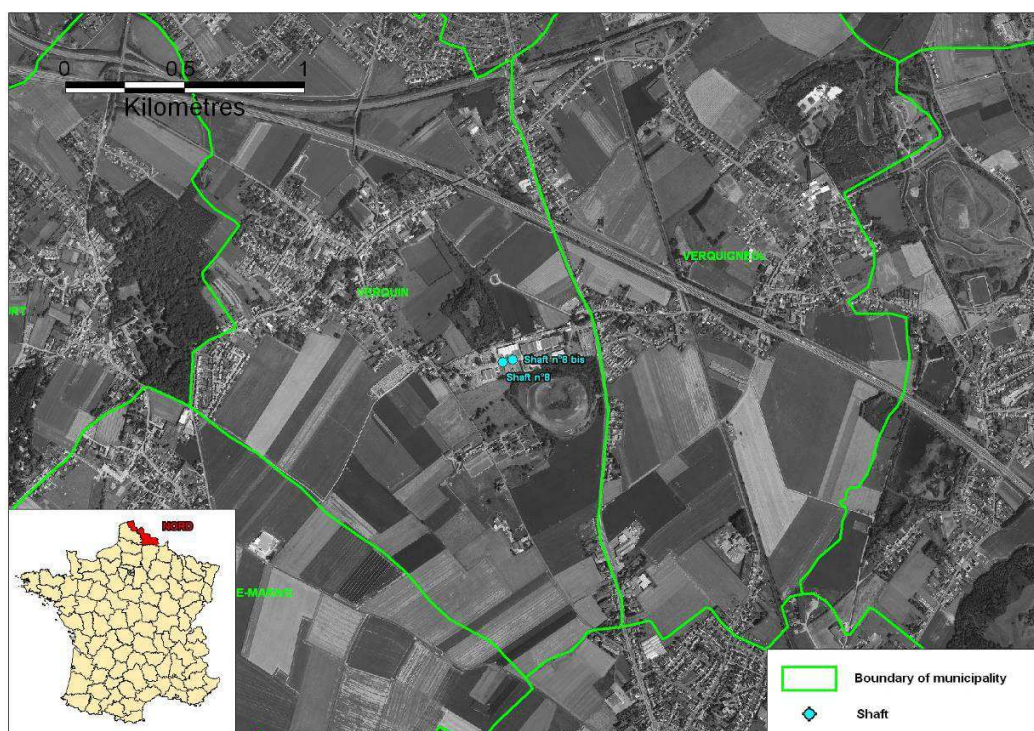
*Figure 8 : Location of shafts n°8 and n°8 bis (Source: INERIS)*

Pithead of shafts n°8 and n°8 bis is located on the territory of the municipality of Verquin (North region of France, Coal mine closed in 1990). Both shafts n°8 (main shaft) and 8 bis were dug in 1899 and opened in 1901. The distance between the two shafts is 40 m (Figure 8).
